KY-01-22-00

SURVEY REPORT
Sailig vessel „AVALANCHE“

Customer	:	Col. Andrew Mills, Hameln
Date of survey order	:	December 1999
Date of inspection	:	7.1.00, 28.1.00, 10.2.00
Participants of inspection	:	Cop. Marc Higgins (7.1.00, 28.1.00) Col. Andrew Mills (10.2.00)
Place of inspektion	:	BKYC, boatshed

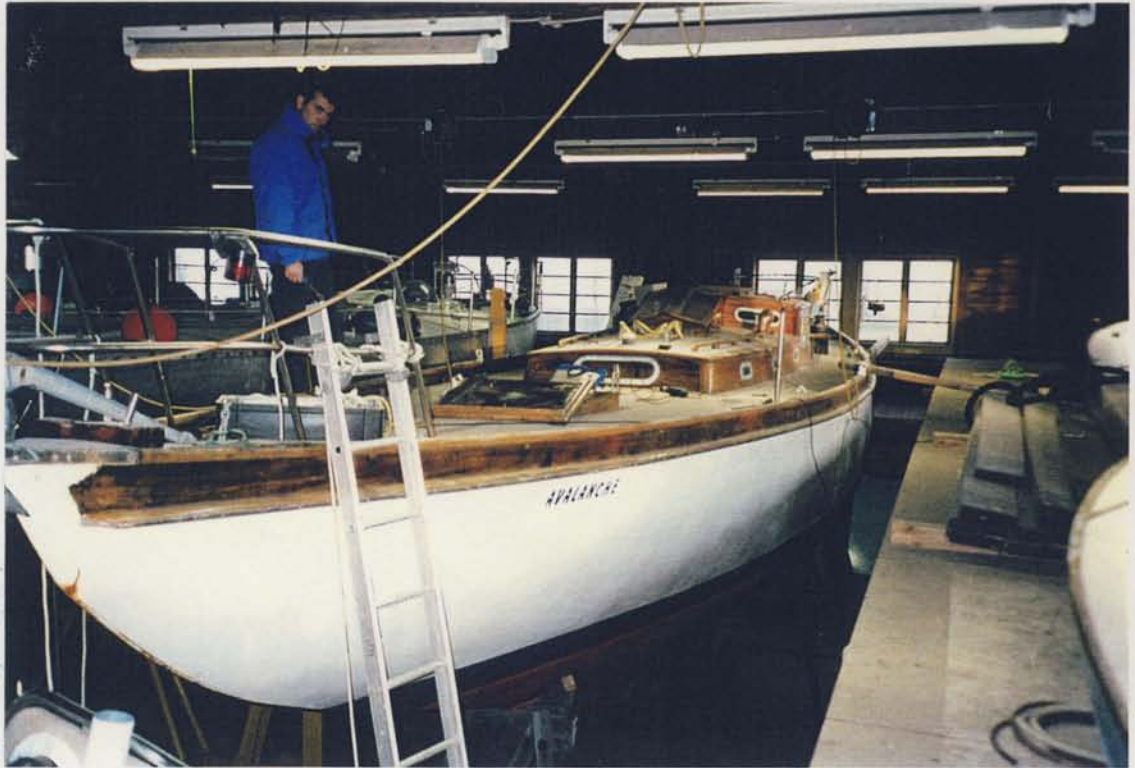
The hull is totally GRP sheated to deck level.

The sheating is in overall good condition with no indication of any separation from the underlying structure. (Photo 1)

The hygrometer „TRAMEX SKIPPER“ gave no indication of moisture between the mahogany planking and the GRP sheat, except the area about 150 mm down from the rubbing-strake all around the hull showed a little higher level of moisture.

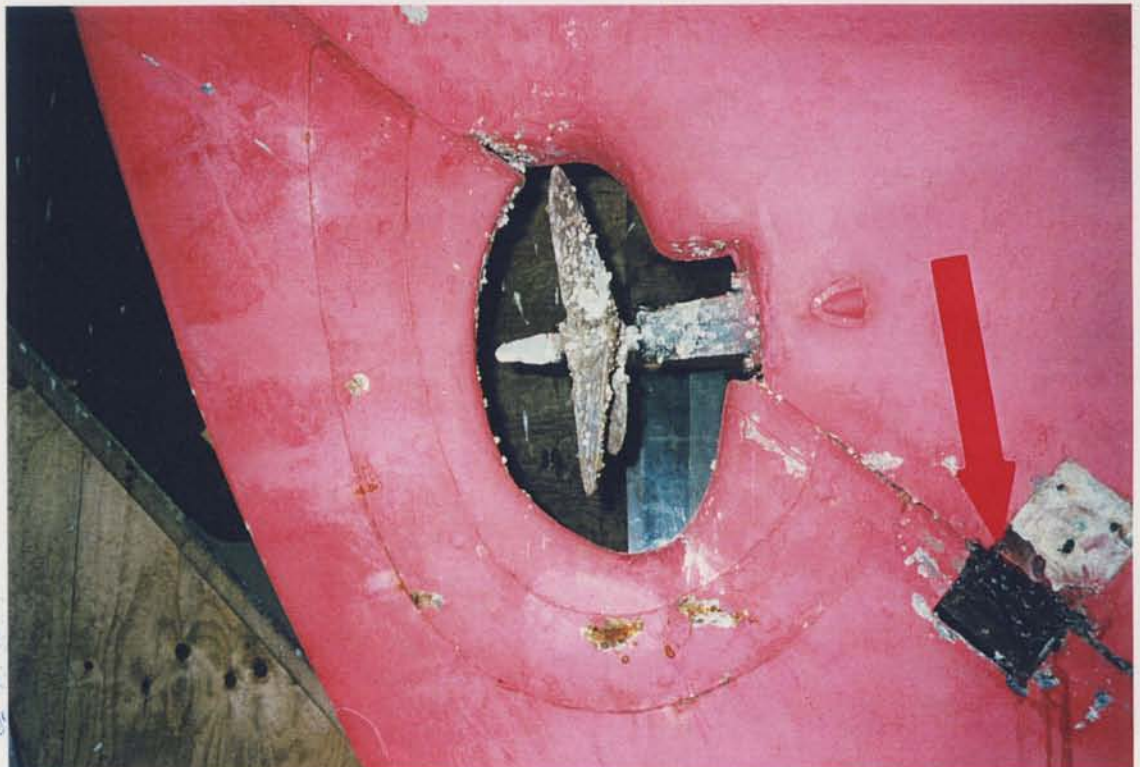
The rudder was made from oak-wood, glued with SIKA-FLEX in two halves. It was reconstructed in 1987.

The halves are going to part from the back to the front.

Under the sheat are drilling holes shown made by the worm TEREDO NAVALIS. (Photos 2, 3)

The rudder is not safe anymore. It needs to be reconstructed.

1. Planking: Replacement of 100 m mahogany planking	DM	58.000,-
Removing and rebuilding of interieur	DM	5.000,-
Removing and renewing of GRP-sheat	DM	2.500,-
2. Rudder : Making a new rudder	DM	17.000,-
3. Frames : New steel floors and wooden frame	DM	7.000,-
4. Gunwale: Renewing of 4 m toerail, rubbing strake and gunwale on both sides	DM	15.000,-
5. Cabin : Refilling the cracks with wooden strips	DM	<u>1.500,-</u>
	DM	108.500,-
		=====

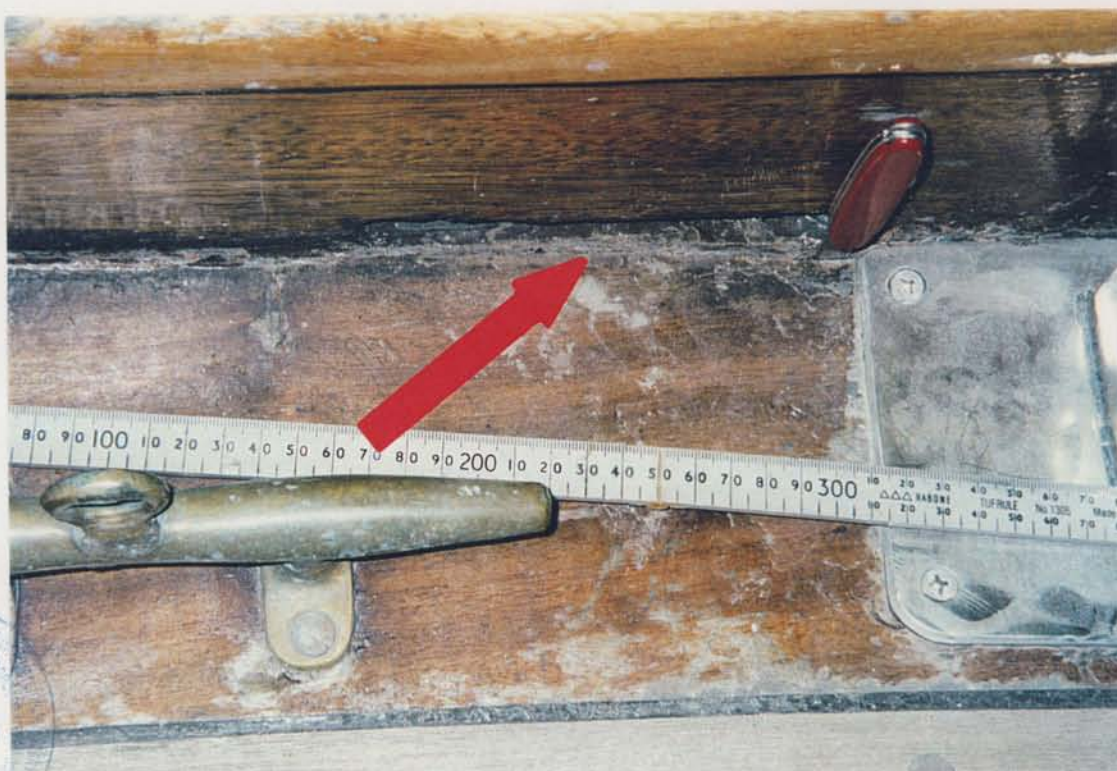
4

The mahogany gunwale is badly broken on port near the chainplates, over a length of 3 m. It must have been leaking badly when the boat was afloat. (Photo 4)

Starbordside is broken too, but not so wide.

For repairing the gunwale, the toe rail with its capping and the rubbing strake has to come off and has to be reconstructed again.

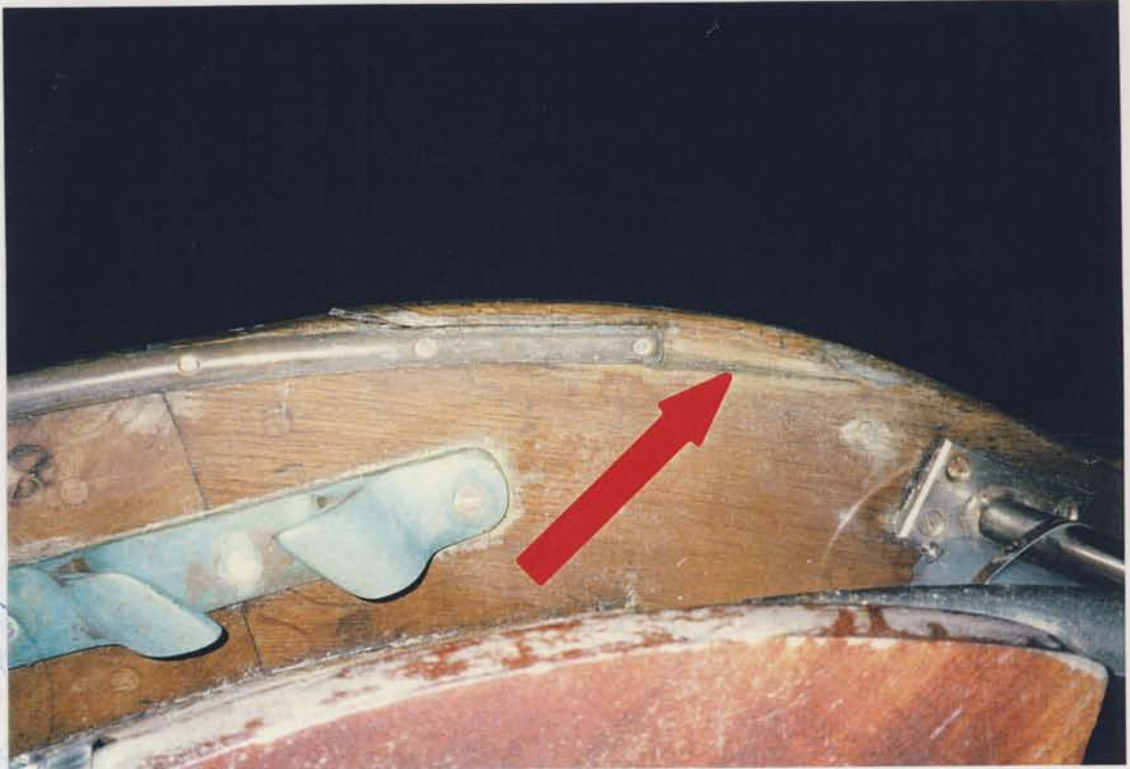
5

The Iroko toerail is in good condition, the Ash capping is split in the aft below the pushpit. (Photo 5) The varnish needs renewing.

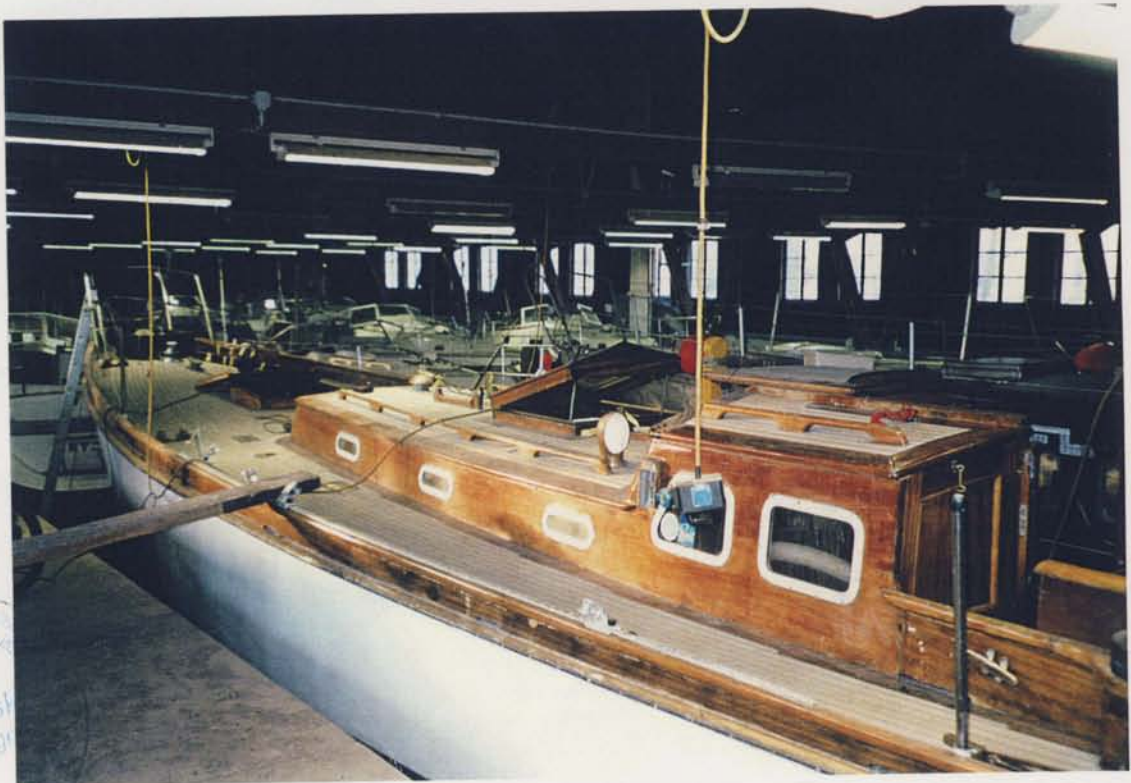
6

The sides of the mahogany cabin and doghouse (Photo 6) are in good condition (except the varnish). The front wall is cracked in some places. (Photo 7,8)

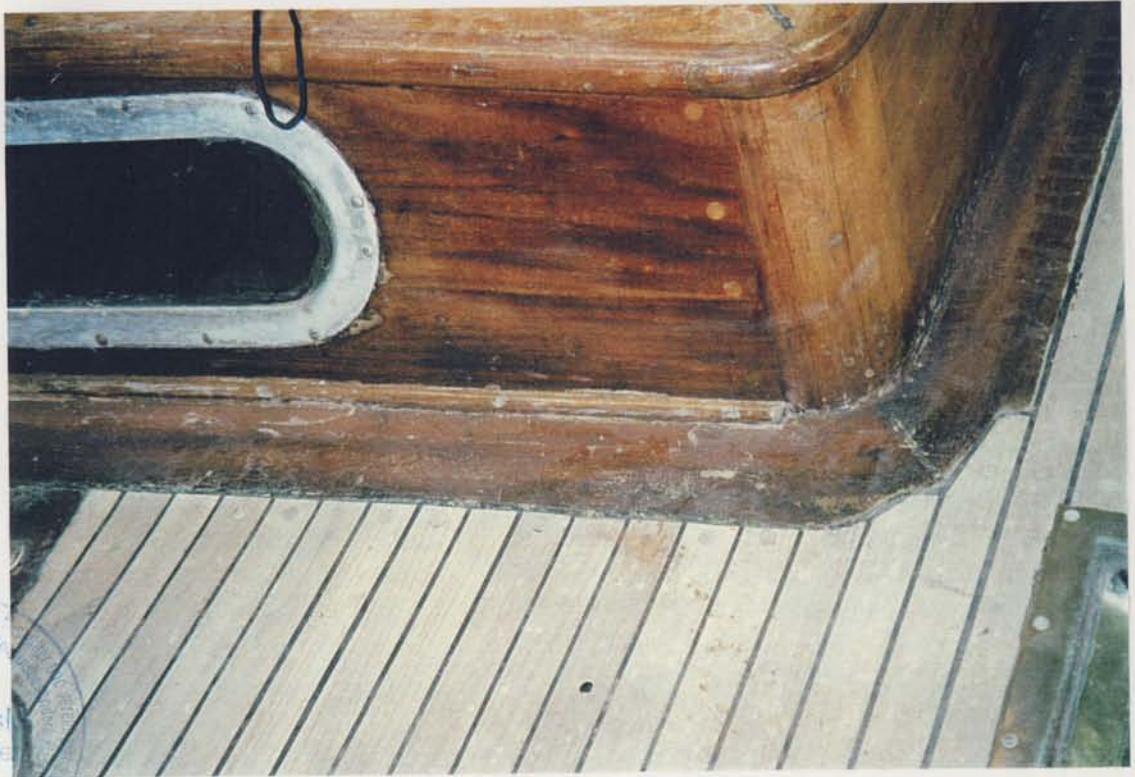
7a

The seam between the cabin wall and the covering board is opened and must be leaking. The seam can be cut out and refilled with mastic compound.

(SIKA-FLEX 290 DC) (Photo 7a, 8a)

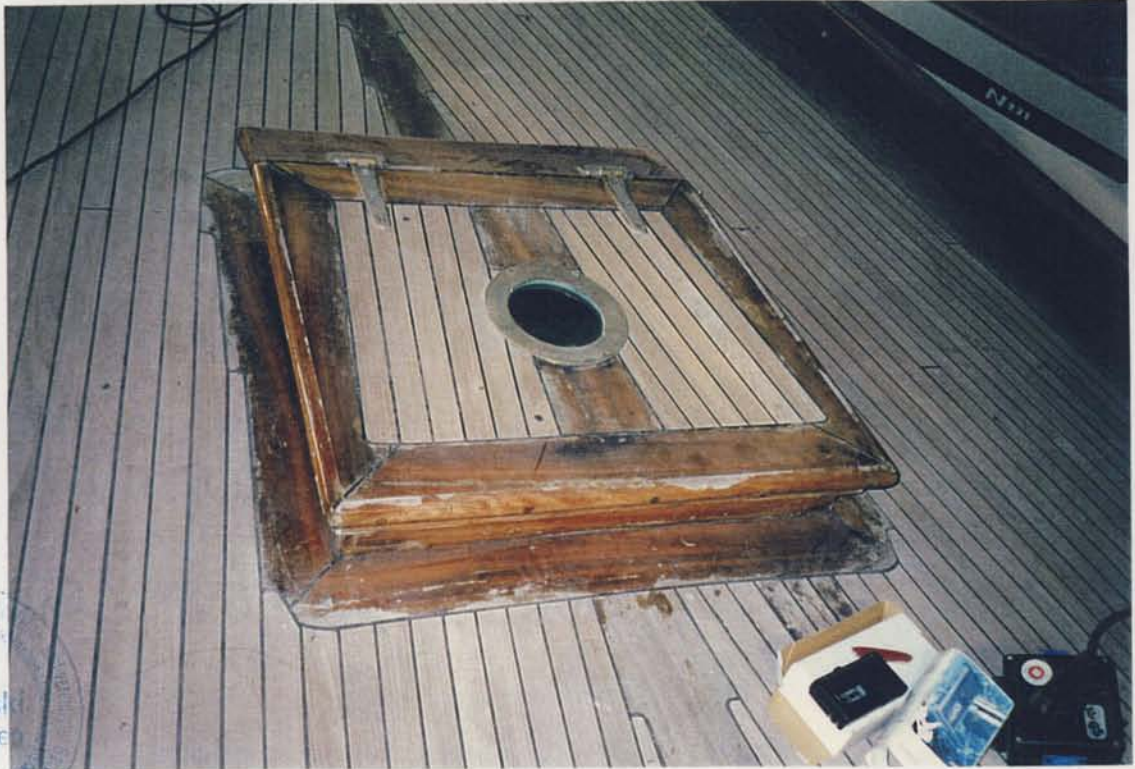
9

The hatches were reconstructed in 1987 not very good, but they will last for another two to four years. (Photo 9, 10)

There are only little things to repair.

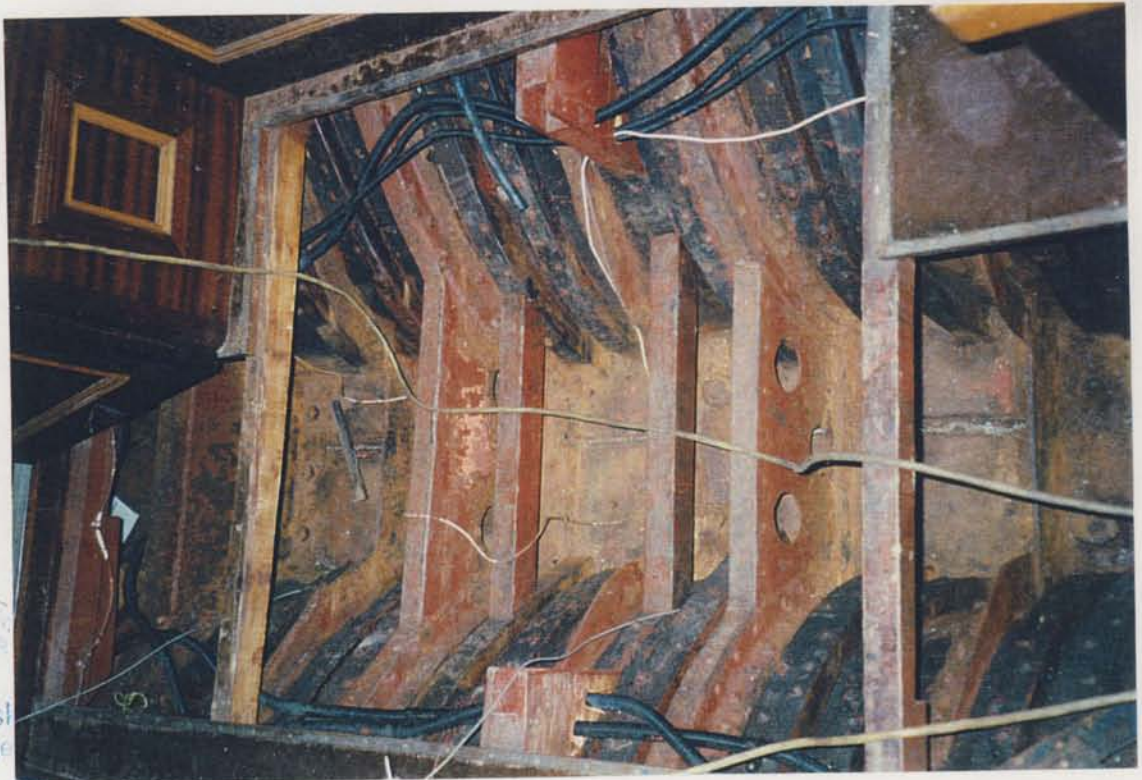
11

Most of the original steelframes and floorings had been replaced in 1987. (Photo 11)

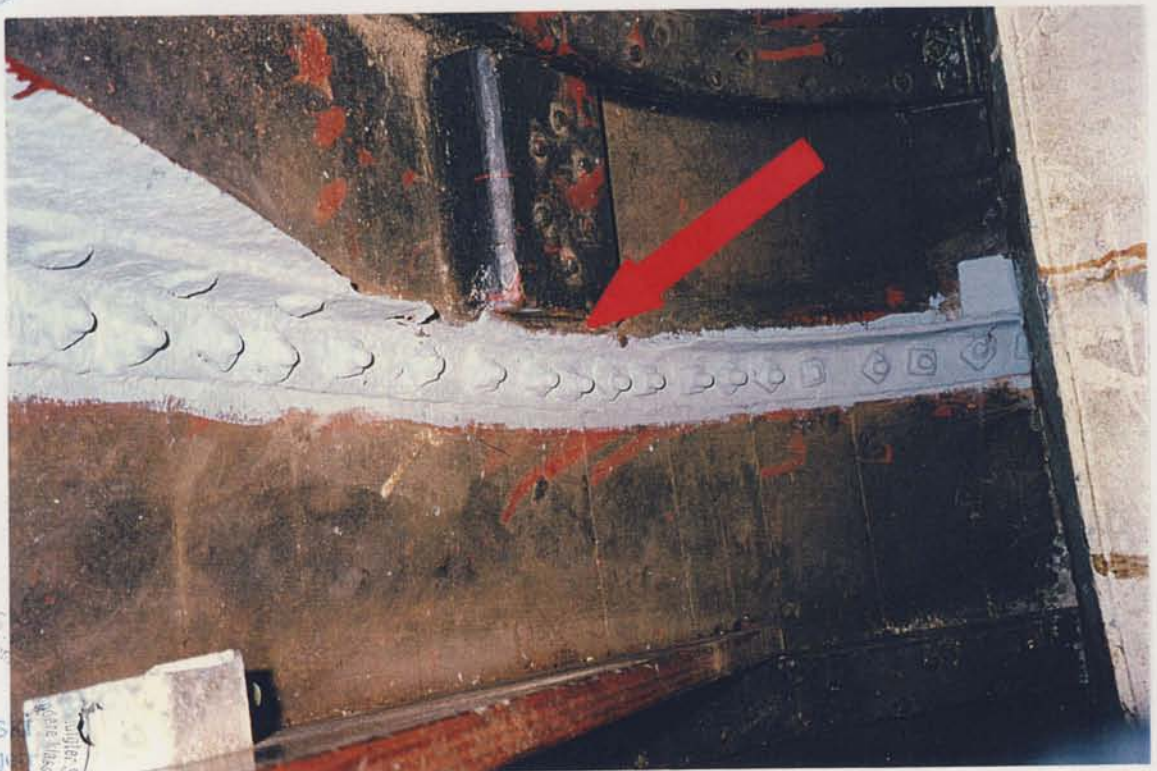
12

In the aft are three pairs of original framings left. The one in the front is corroded badly, it needs to be replaced. If it seems to be too difficult making a steel-one it could also be made from laminated wood. (Photos 12, 13).

All the corroded old frames should be taken out.

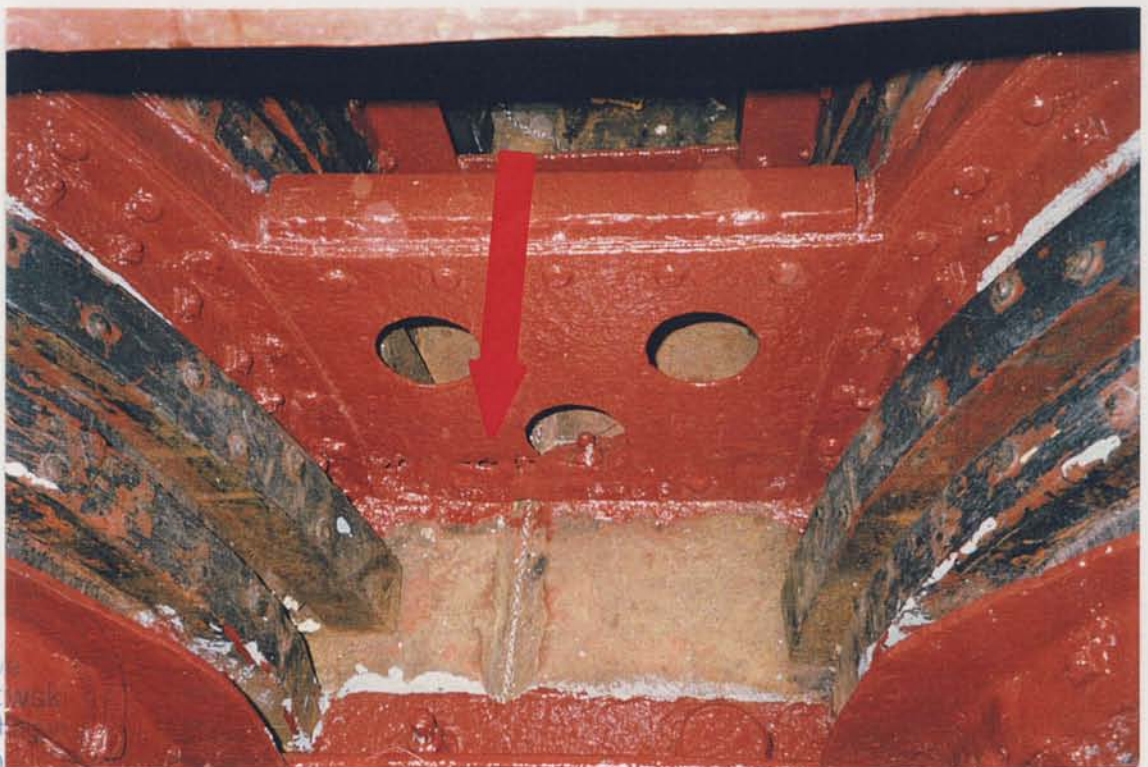
14

Two steel-floorings in front of the engine are badly corroded, they need to be replaced. (Photo 14, 15)

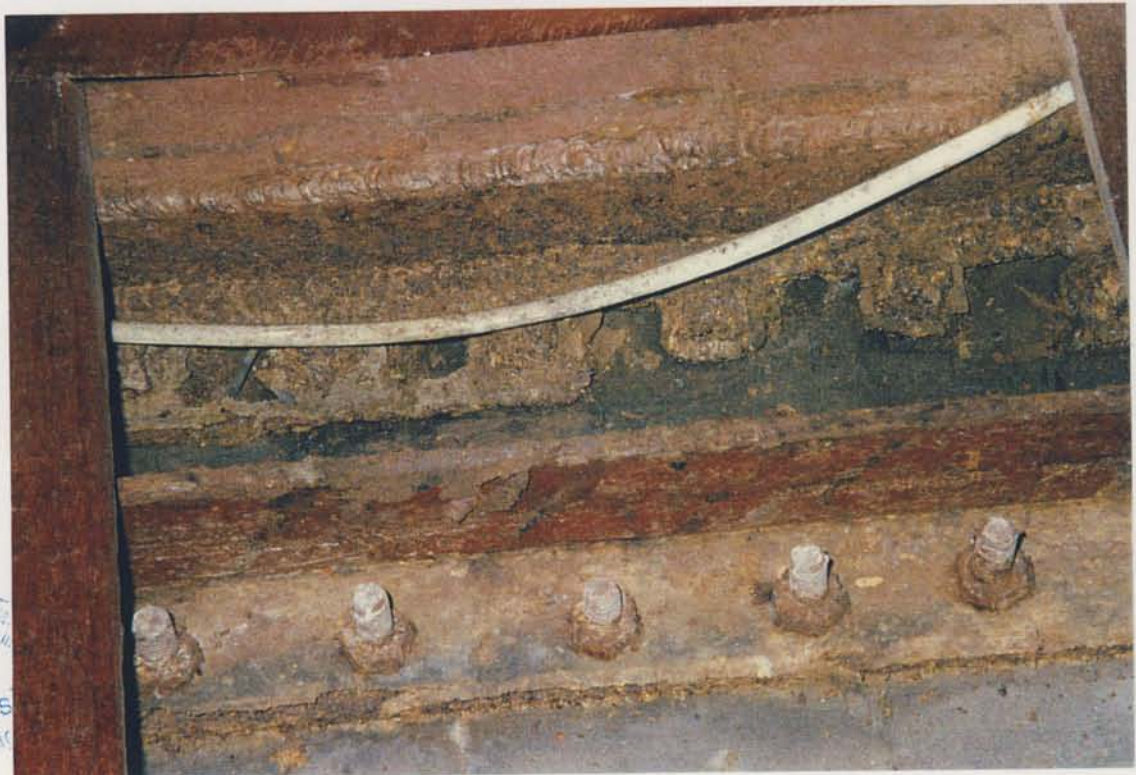
16

The new steelframes are very rusty on the surface. They are to be brushed with a metalbrush and coated with anti-corrosive paint. (Photo 16, 17)

The material of the steelframes had not become thinner yet.

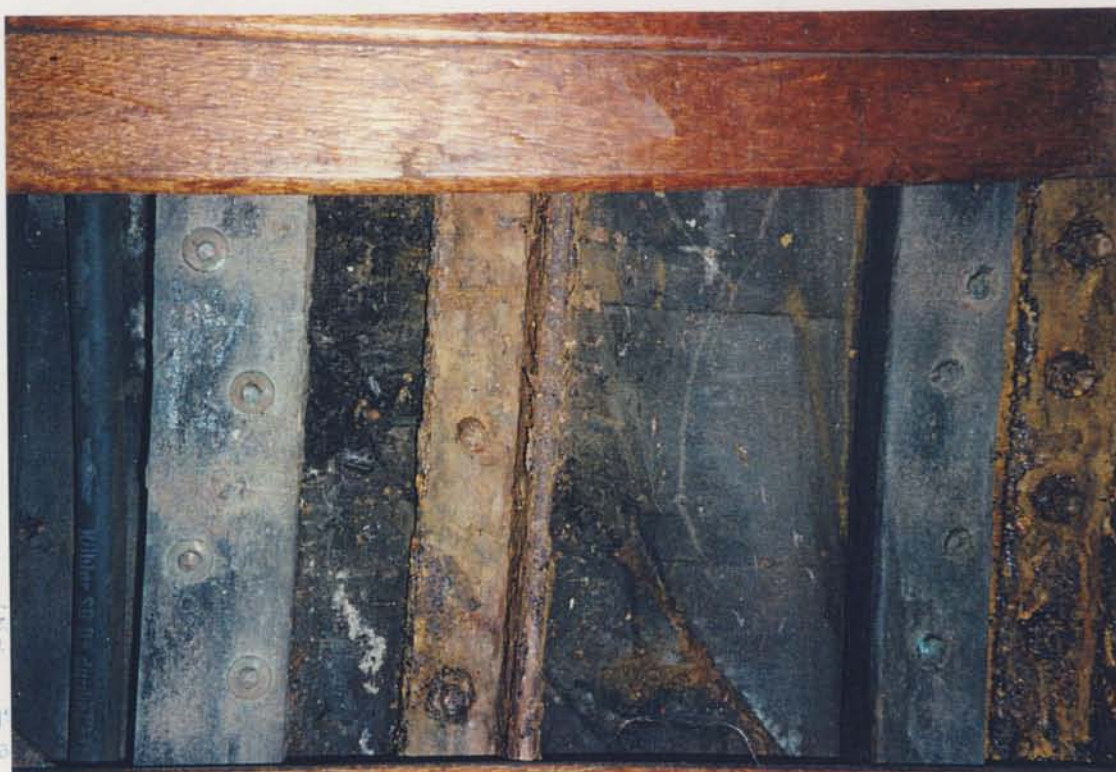
18

The new laminated, copper-riveted wooden frames came in 1987, they are still in good condition and give the vessel a good strength and stiffness. (Photo 18)

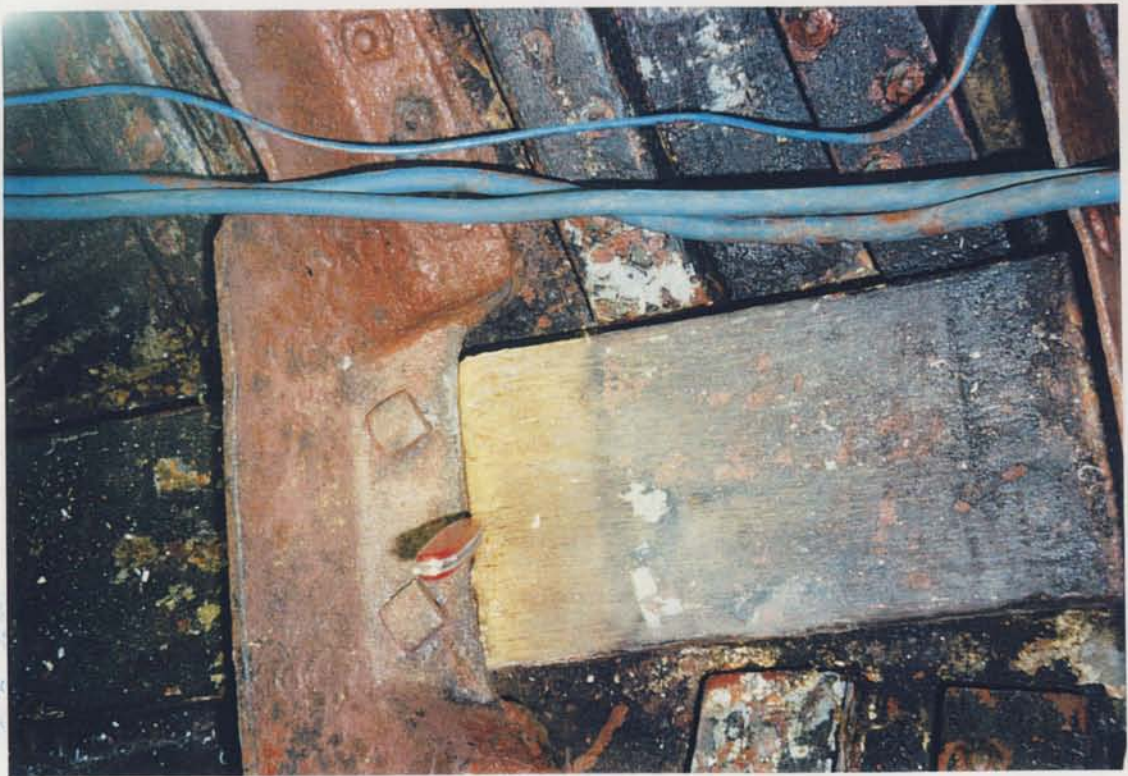
19

Stem, keel and backbone, all oak, are in good condition.

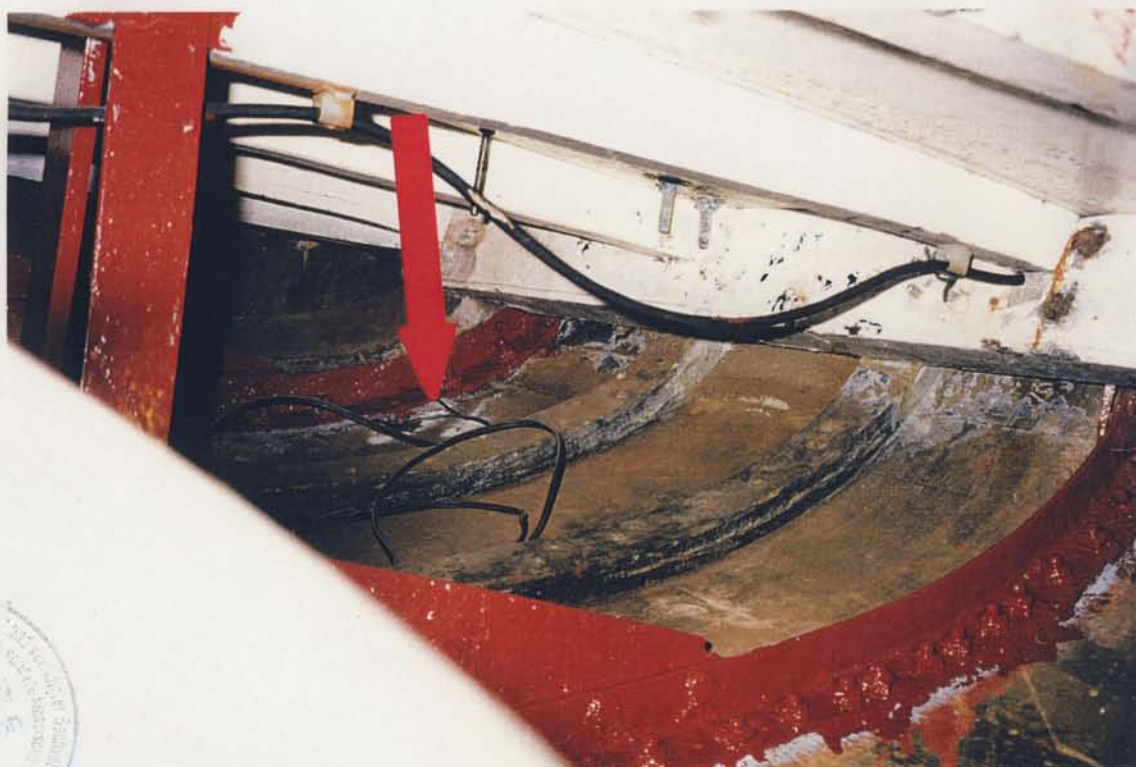
21

The mahogany planking, 1 3/8", is attacked by dry-rot in some places:

- 1) On portside in the very aft under the last steelframe, four planks.
The attacked places are not so big yet. They can temporarily be cut out, dried and filled up with Epoxi-Resin.(Photo 21)
These places are to be cheked every year.
- 2) In the main-saloon beneath the berth on both sides five planks are attacked by dry-rot under some steel-frames over a length of five metres.(Photo 22, 23)
These planks are to be replaced, what means that the GRP sheat must be removed and after finishing the planking the sheat must be renewed.
The rot-progress will keep on, because there is no insulation (tared canvas) between the new steel-frames and the hull planking.
The progress could be stopped by applikation of Boiled Linseed Oil between steel-frame and hull planking.
The planking is to check every year.

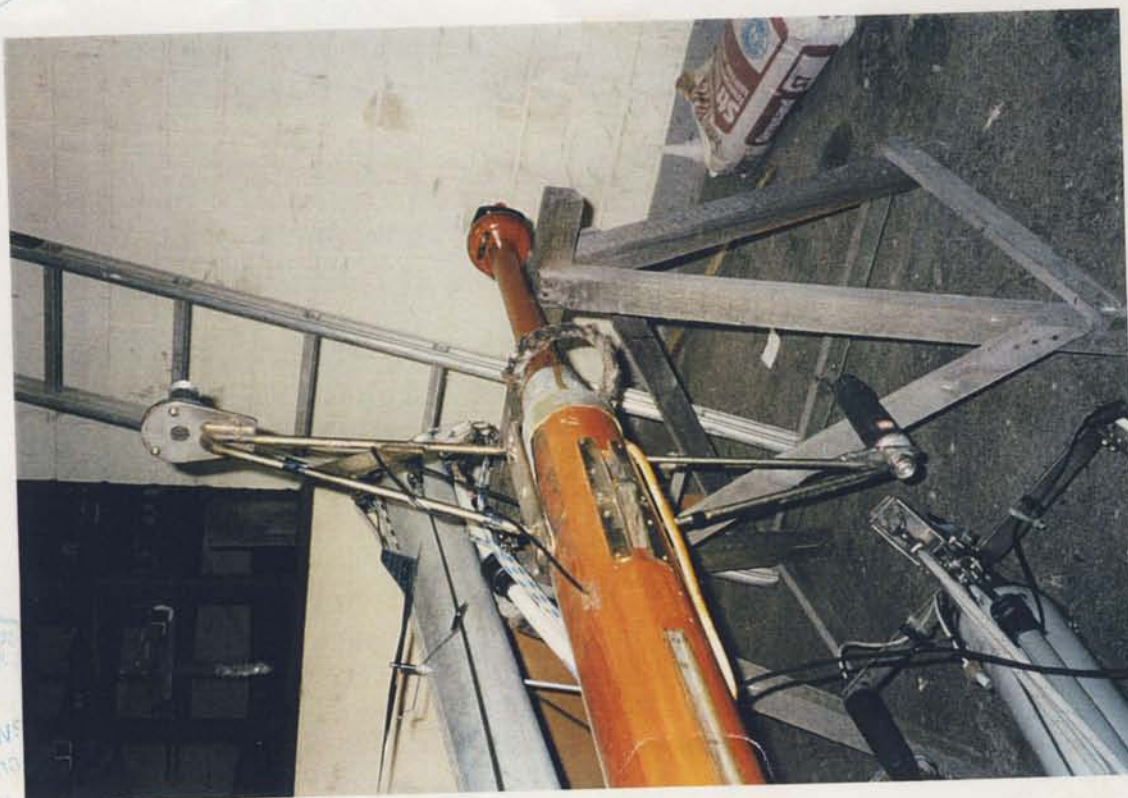
24

Mast and boom from hollow spruce are in good condition, so is the stainless steel shrouds.
